The “Waaghaus” of Bolzano

Energy efficiency, hygrothermal risk and ventilation strategy evaluation for a heritage building

D. Exner, M. Larcher, A. Belleri, A. Troi and F. Haas

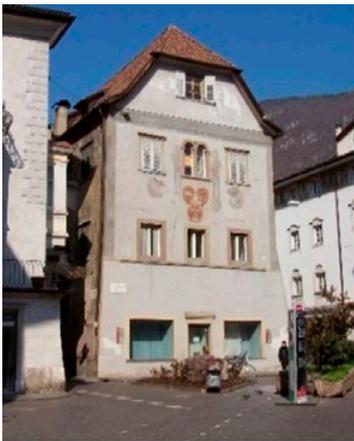
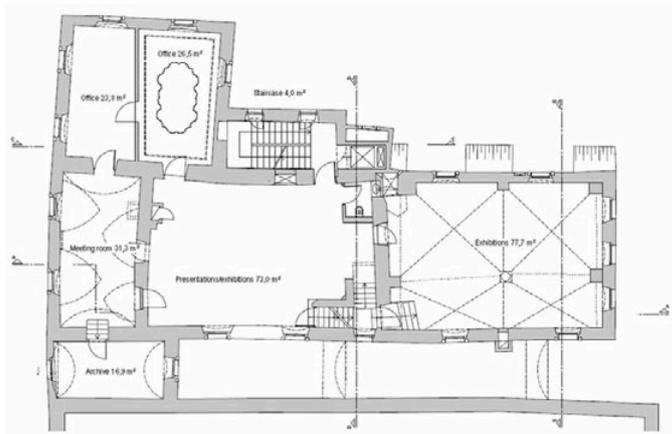
- Date of construction: Romanesque origins
- Heated net floor area: 878,7 m²
- Heated gross floor area: 1.178 m²
- Heated gross volume: 4.776 m³
- S/V ratio: 0,41
- HDD: 2791 (HDD)

Figure 1. Medieval Waaghaus in Bozen/Italy (© EURAC); 1st floor plan. © Architekten Piller Scartezzini).

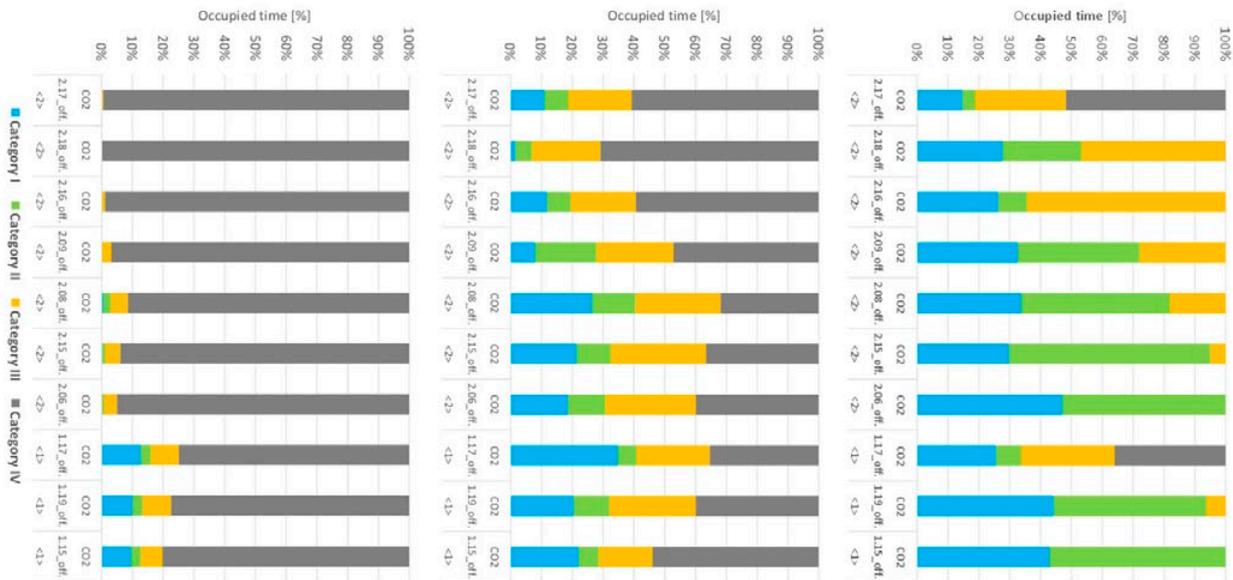
Figure 2. Percentage of occupied time when CO₂ levels are within Category I (CO₂ < 670 ppm), II (670 ≤ CO₂ < 820 ppm) and III (820 ≤ CO₂ < 1120 ppm) according to [10] in each office zone at 1st and 2nd floor for (a) natural ventilation one time/day, (b) natural ventilation three times/day and (c) active overflow ventilation.

Indoor air quality simulations for the three cases show that only the continuous air exchange with active overflow ventilation (strategy “c”) can assure acceptable CO₂ levels during working hours, i.e. CO₂ concentrations at least within category III according to EN 15251:2008 [11], see Figure 2. Operating windows for three times a day (strategy “b”), can assure up to 65 % of the occupied time with acceptable CO₂ concentrations. Operating windows only one time a day (strategy “a”) leads to acceptable CO₂ levels for less than 25 % of the time.

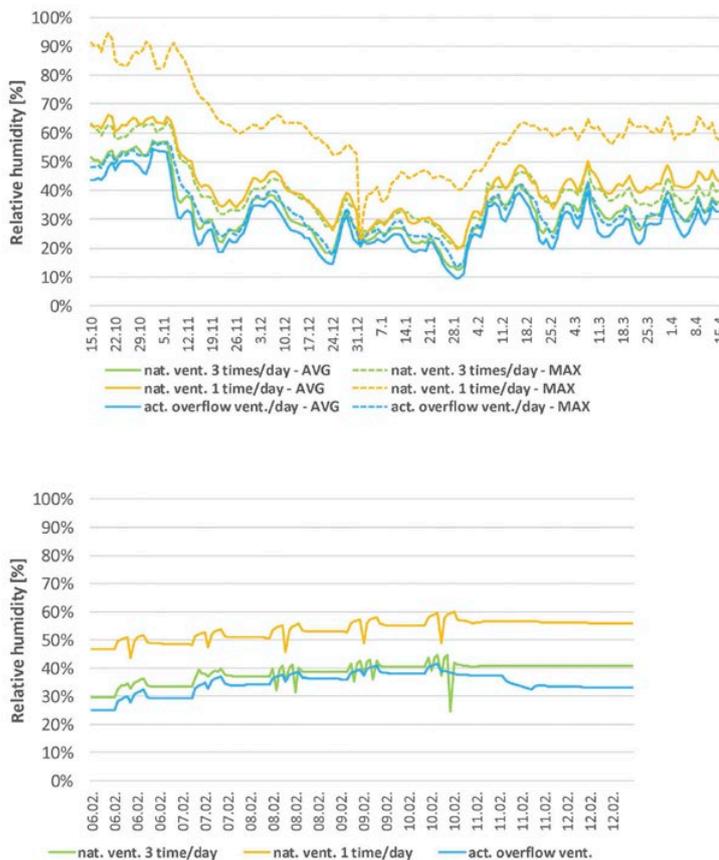
Figure 3. (a) Trend of daily average relative humidity [%] of 1st and 2nd floor (solid lines) and daily max. average of one room (dashed lines) for the winter period. (b) Trend of hourly average of 1 room for 1 week in February for the three simulation cases (natural vent. 3 or 1 times/day, active overflow vent.), © EURAC.

Looking at the daily average values of relative humidity (Figure 3a), we can see that active overflow ventilation keeps the relative humidity under 40 % for most of the winter period (average 1st and 2nd floor winter period: 29.1 %). Slightly higher values are obtained when ventilating three times a day (average 1st and 2nd floor winter period: 32.8 %). Ventilating only once a day results in even higher humidity levels (average 1st and 2nd floor winter period: 41.5 %). This is mainly due to the

fact that excess humidity cannot be disposed at the end of the day and remains in the building overnight. Whether this is still acceptable from hygrothermal point of view is discussed in the next section (3.3).
