# Office Building, Roskilde, Denmark

Parkvænget 25, 4000 Roskilde

## IEA – SHC Task 47

Renovation of Non-Residential Buildings towards Sustainable Standards

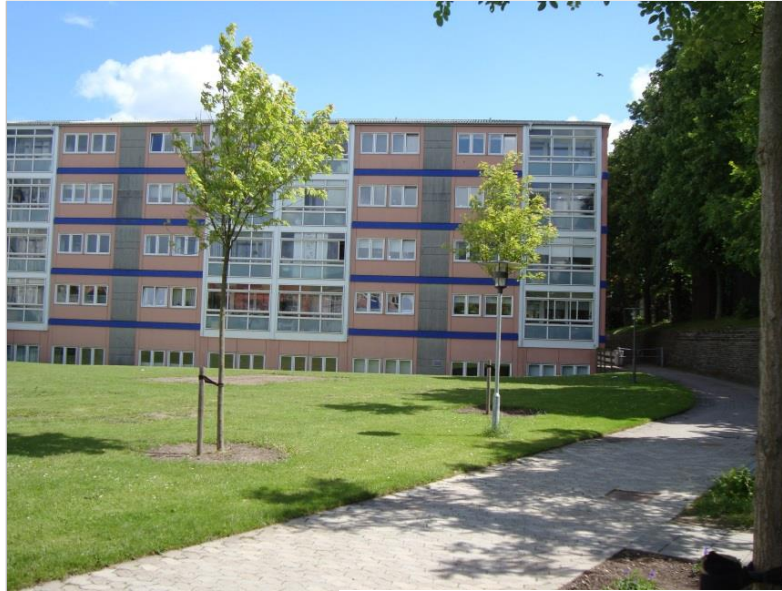
*Left: There are no photographs of the original office building, but this picture shows the back of a similar housing complex that was built at the same time and renovated in the same style as the office building (in 1991). The facade of the building had deteriorated and needed an upgrade. Windows were worn down and energy inefficient.*

*Right: The back of the new office building has a more regular and contemporary facade. The housing company (Boligselskabet Sjælland) wanted the facade to express a much more modern look, something that could reflect the company's profile as a modern and professional business.*

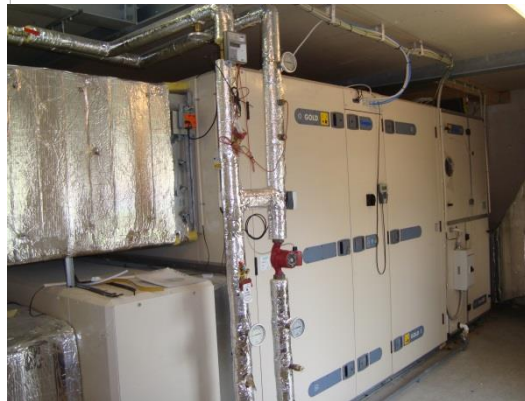
*Below:* The ventilation system is placed in a separate building and includes the possibility of delivering 80 kW cooling in the building before working hours to avoid overheating on hot and sunny summer days.

The building had no cooling system before the renovation. An 80 kW cooling unit was added to the ventilation system. It can be used to cool the building before working hours. A separate free cooling system for the server room and individual printer rooms was also added.

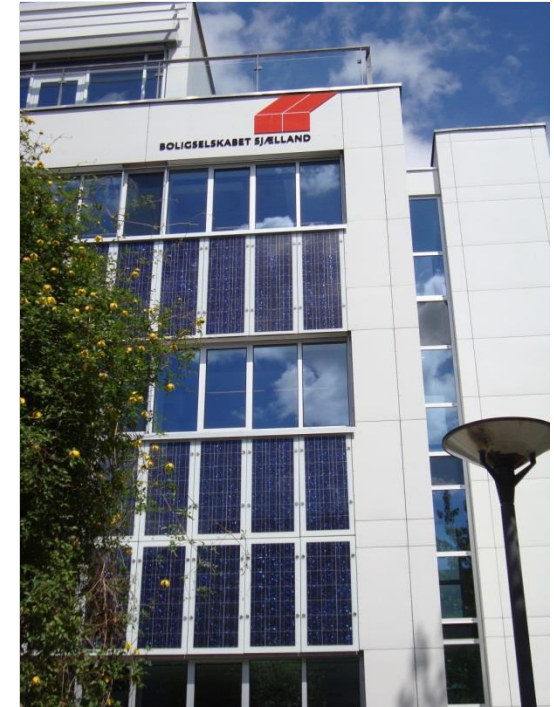
*Above:* The 130 m<sup>2</sup> PV panels on the southern facade produce only a relatively small amount of electricity compared to the overall electricity use in the building (see graph on the left). However, the PV panels also serve as part of the aesthetic appearance of the building and gives the impression of a modern building that also signals the green profile of the company.

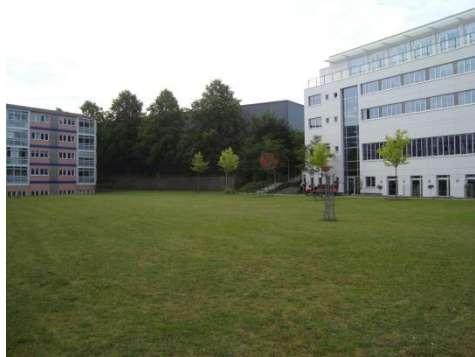
*Above: This picture shows the new facade (right) as well as the old one (left).*

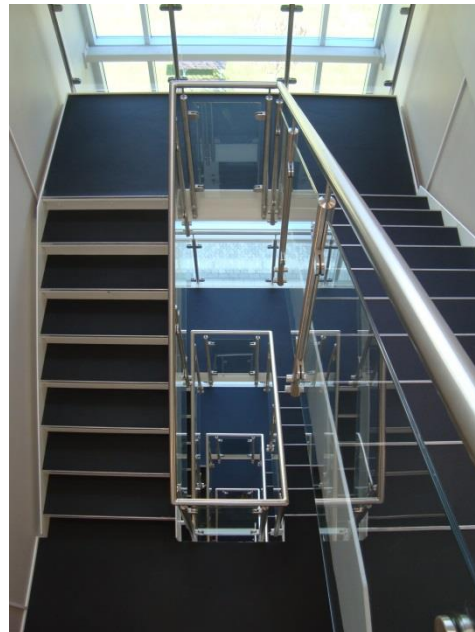
*Below: The stairwells are much brighter after the concrete facades have been replaced with glass facades. All windows are made with sunscreen to limit overheating.*

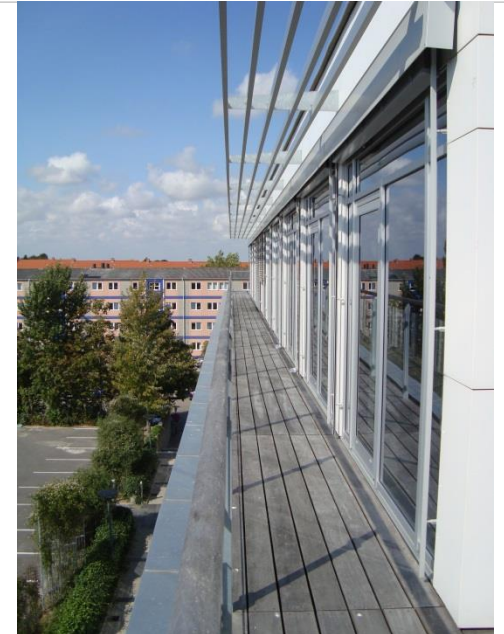
*Above: The penthouse has both vertical and horizontal solar shading to avoid high indoor temperatures during summer.*
